**2005/2006 Annual Inspection  
Report**

**CAMERON PRAIRIE REFUGE  
PROTECTION PROJECT  
(ME-09)**

State Project Number ME-09  
Priority Project List 1

October 21, 2005  
Cameron Parish

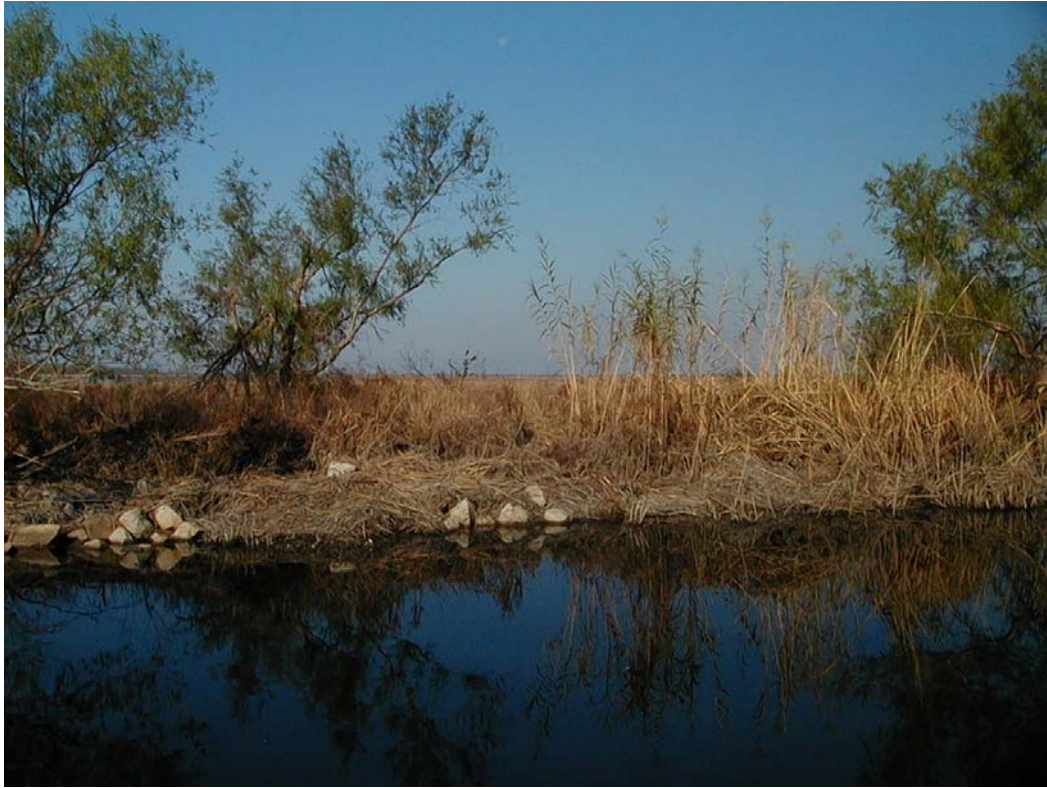
Photo 1, Tie in to North Prong Canal

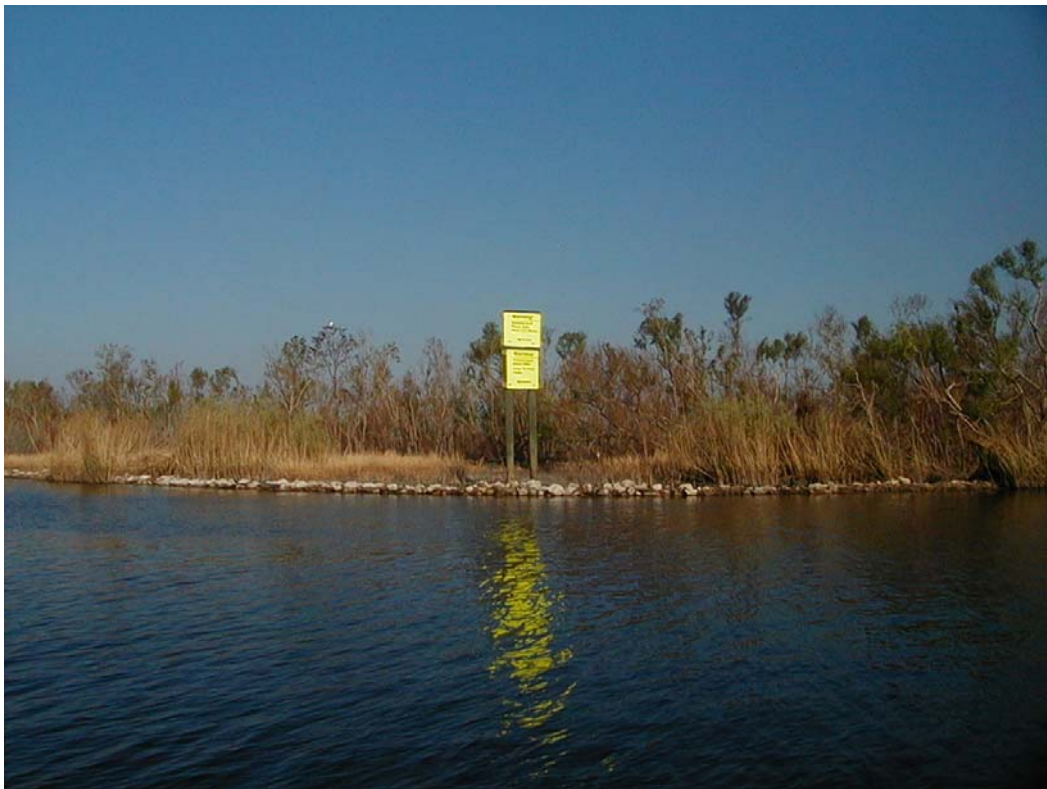
**2001 – Warning Sign Addition (USACE)** – The US Army Corps of Engineers added warning signs along the northern boundary of the project in August 2001 in response to complaints from the commercial traffic traveling along the GIWW. This is not a project feature to be maintained through CWPPRA.

Photo 2, Signs installed by USACE
